# ST. ADALBERT CATHOLIC CHURCH

SOUTH BEND, INDIANA

# Structural Investigation

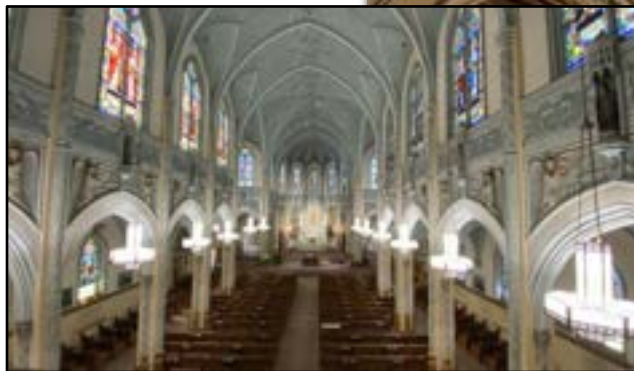
EXISTING CONDITION 2023

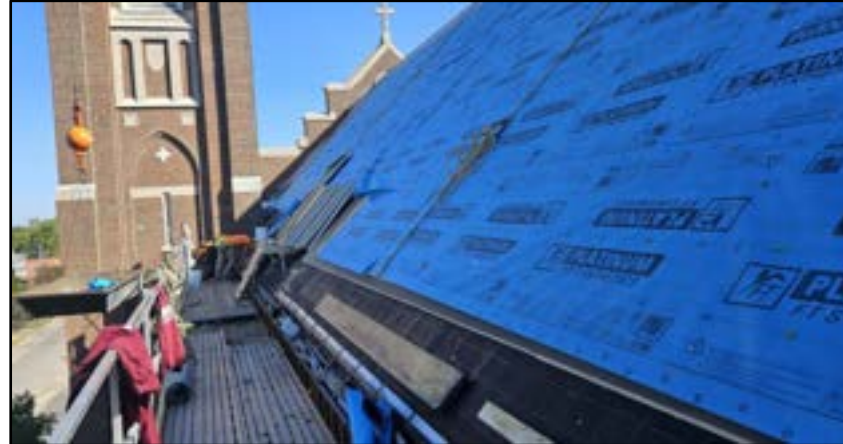
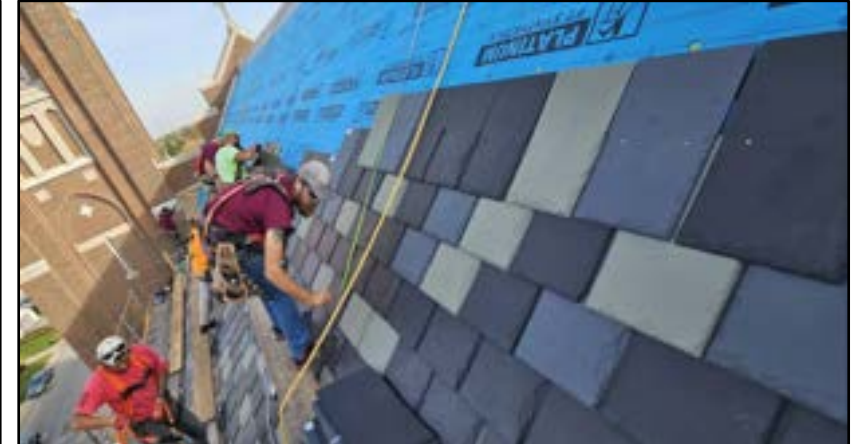
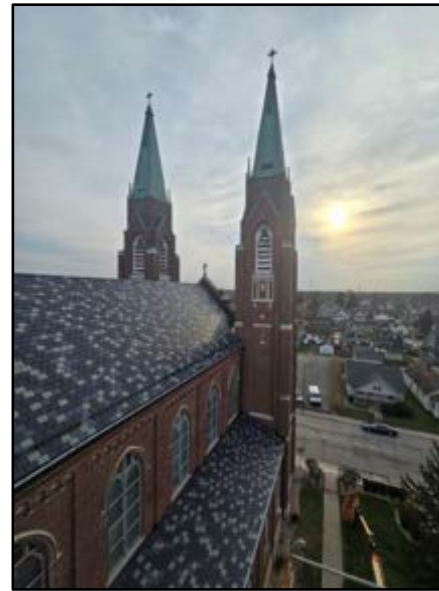
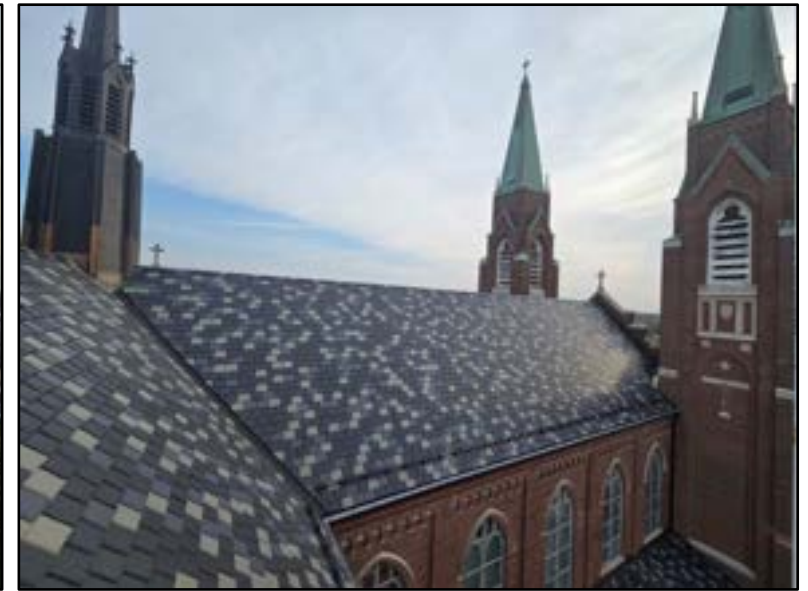
- Roof deck repairs
- 4" of rigid roofing insulation with ice & water Shield.
- Eco star synthetic Slate
- Belltower copper roofing repairs

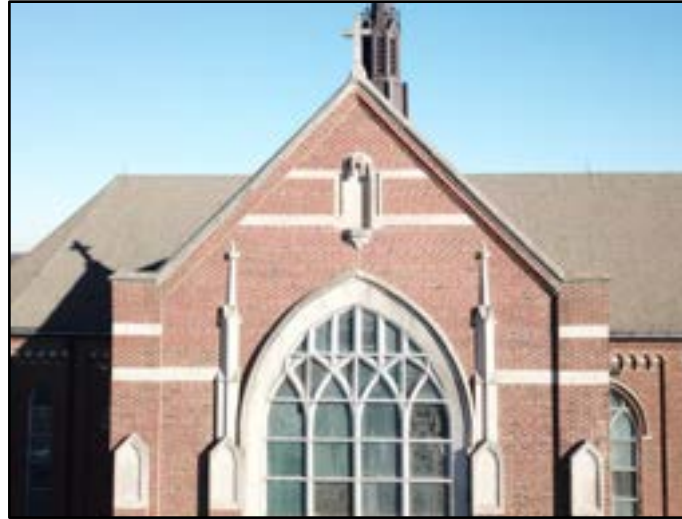
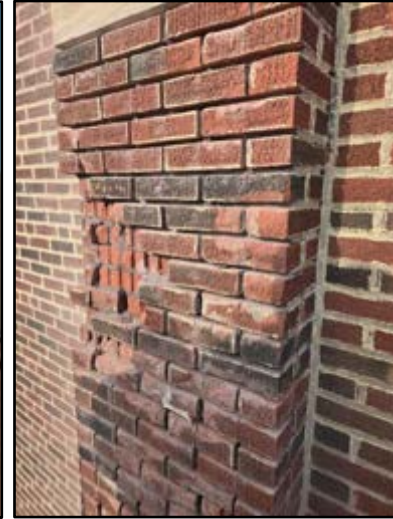
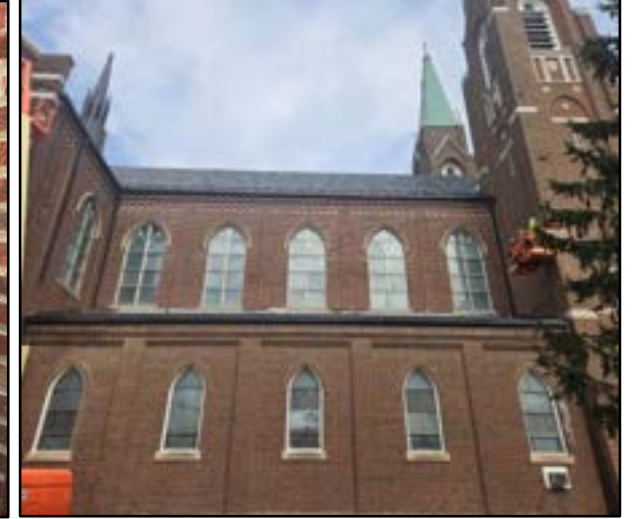
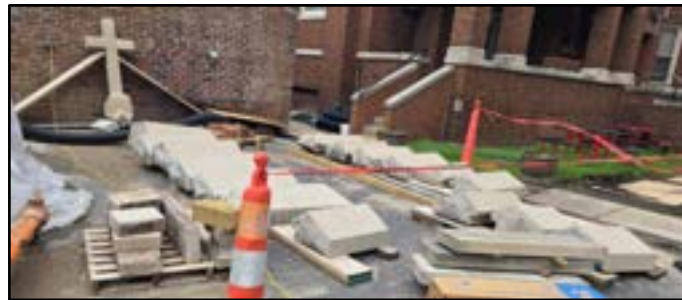
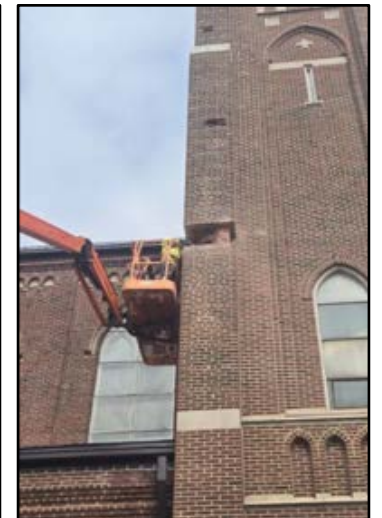
- Brick and limestone repointing around building and inside towers
- Mortar color matching
- Limestone repair/patching
- Transept coping stone anchorage
- Fracture cracks at tower corner piers

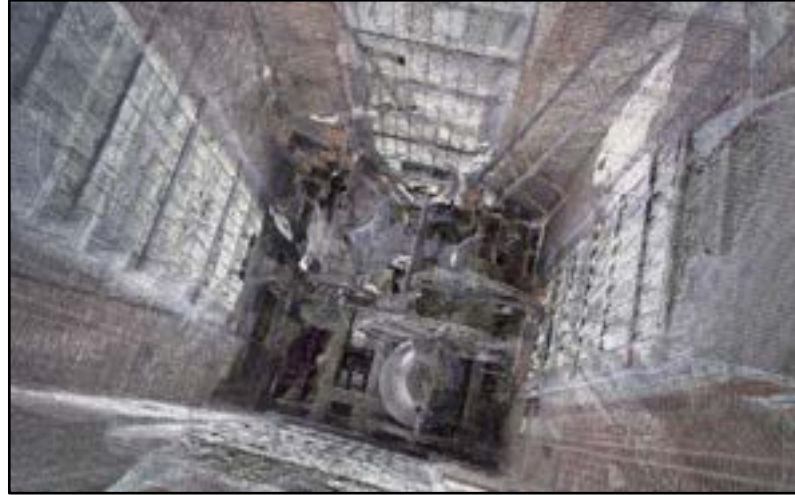
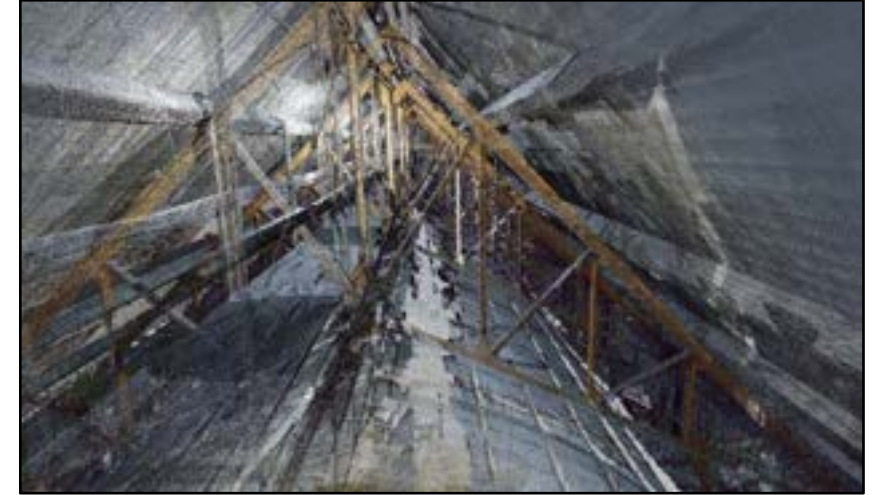
- Thermal Expansion
- Moisture Expansion
- Frost Expansion
- Rust Jacking
- Portland Cement Mortars
- Wind

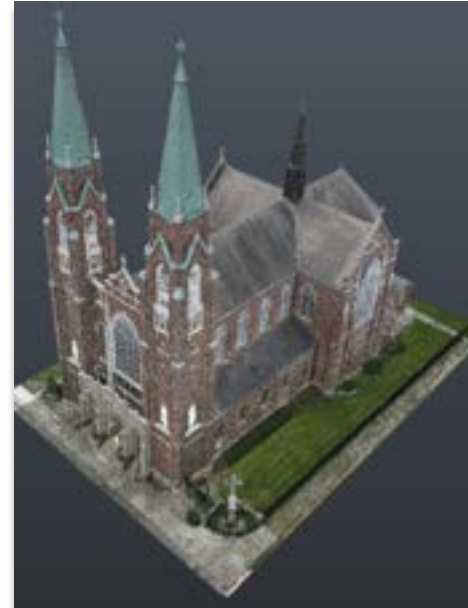
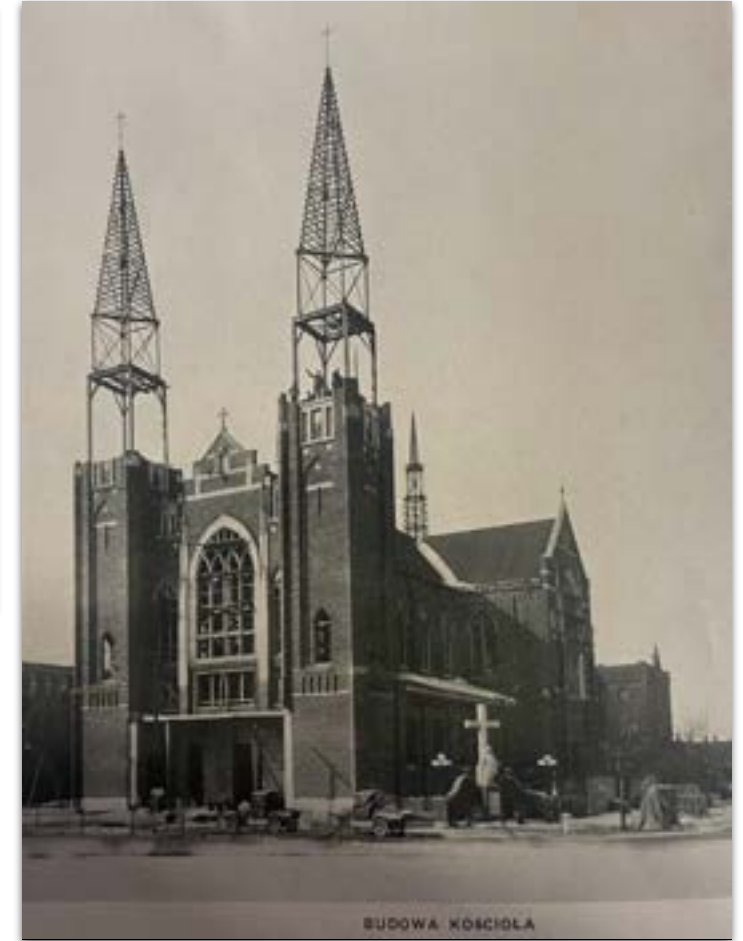
- Finite element model of the towers
- Calibration of the model based on crack/wind analysis
- Identification of the leading problem

**Lack of stiffness causing severe torsion**
